TECHNICAL SERVICE BULLETIN

Product: IDC Pro MFV Valve

Subject: IDC Pro Plunger Tip Material Change for Carb Water / Plain Water Valves

Date: 02/07/2020

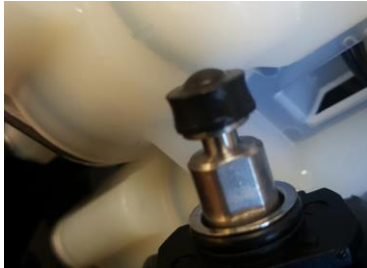
The current carb water and plain water plunger tip, PN: 620711131 is swelling under high pressure. The swelling of the CW or PW plunger tip can reduce the flow rate or prevent the valve from opening. This is typically caused by a recirculation system but can occur under higher water pressures.

Over pressurization and introduction of chloramines in the water supply causes the plunger to swell over time.

Swelled Plunger Tip

If you encounter a swollen plunger tip on the CW or PW MFV valve, replace the plunger tip with the new EPDM material; PN: 620070041

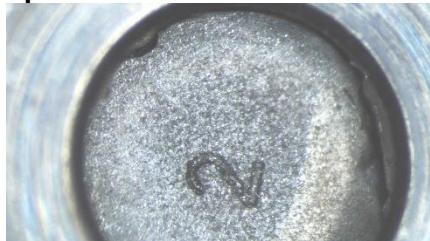
Current Tip-P/N 620711131: No Circle around the cavity number

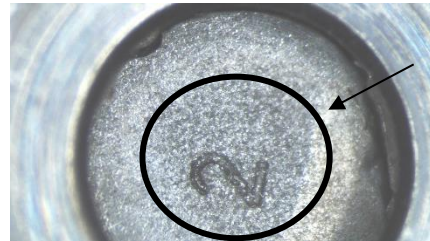
New Tip-P/N 620070041: Circle around the cavity number
