TECHNICAL SERVICE BULLETIN

Product: Cornelius Viper

Subject: Condenser Fan PN replacement 620073140

Date: 10/22/2021

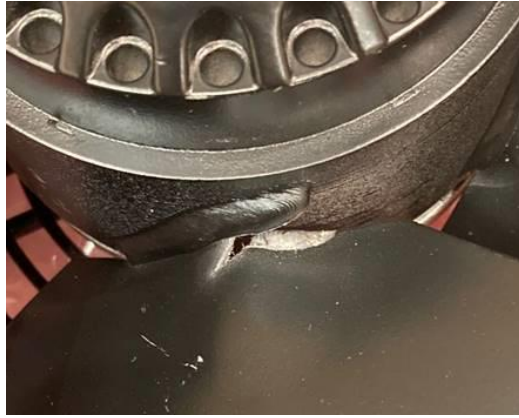
On a small percentage of Viper units, there is potential for the fan blade to develop a fracture or crack near the fan blade hub. While this condition does not create a safety risk; if left unrepaired it could require additional repairs to the shroud or condenser components.

Improper attachment of fan blades to condenser fan motor.

Damaged Fan Blade

- Replace the damaged fan, using replacement fan PN: 620073140. Identification for new fan is a presence of green paint mark as depicted below:

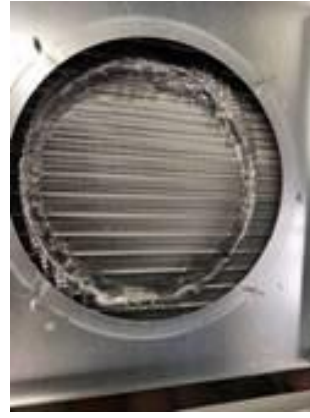
Damaged Condenser

- If the condenser is damaged, replacement of the condenser is also required.
