TECHNICAL SERVICE BULLETIN

Product: Cornelius Viper Elite - All Viper Faceplate Variations

Subject: Viper misaligned faceplate identification and corrective action.

Date: 10/8/2020

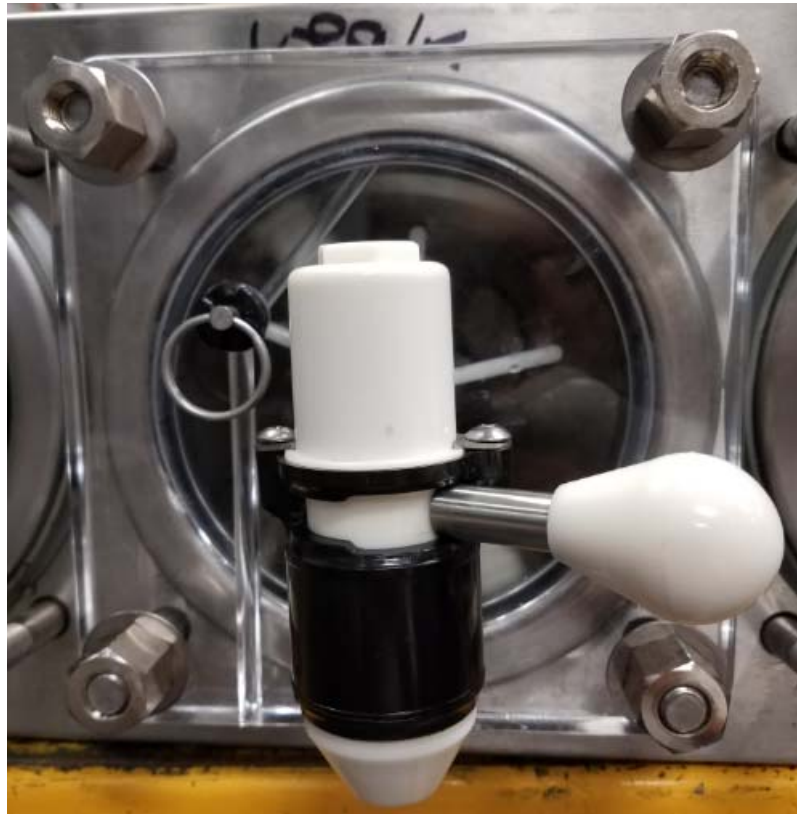
1. **Misaligned Faceplate:** The Faceplate can be installed on an angle due to overtightened nuts, See Figure 1. The product might not leak out the barrel but extra stress will be applied to the barrel assembly, resulting in potential component failure.

Figure 1 – Misaligned Faceplate (Bottom Nuts Overtightened). Motorman Valve Shown, but Applicable to all Valve Variations.

Additional Info: It has been tested that a faceplate can be installed incorrectly onto an existing Viper barrel by unevenly tightening any of the 4 mounting nuts. When the faceplate is misaligned it directly impacts the position of the beater bar. Once the beater bar is out of position it exerts extra stress on the barrel. The Faceplate Spacers prevent misalignment by eliminating overtravel of the mounting nuts on the threaded rods. With these new Faceplate Spacers, the faceplate cannot be installed misaligned without product leaking out the barrel.

- Install new Faceplate Spacers to prevent potential barrel damage due to faceplate misalignment.

Conclusion: All Vipers should be regularly checked for misaligned faceplates and potential barrel damage. Installing these new Faceplate Spacers is the best way to prevent potential barrel damage. Faceplate Spacers Kits can be ordered directly from Marmon Link as needed.

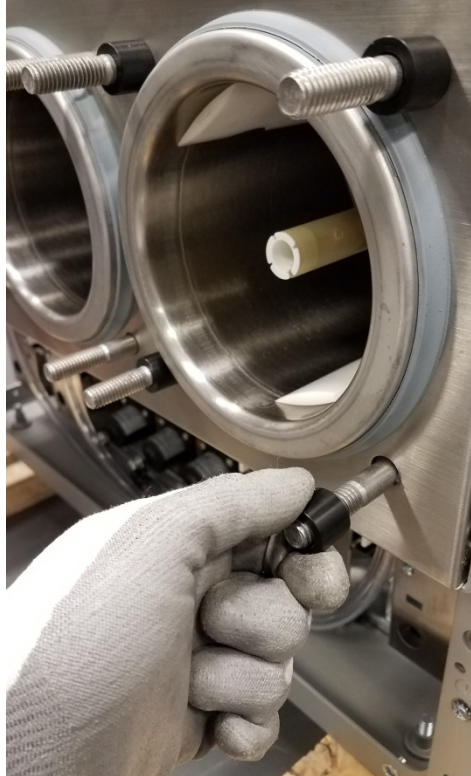
Instructions for installing Faceplate Spacers	
Step 1	Install four (4) new Faceplate Spacers over the threaded rods. Push the spacers back until they are flush with the foam pack. If the spacers are difficult to push in then the installation of the faceplate will ensure they are seated properly, See Figure 2.

Figure 2 - Faceplate Spacers Installation

Step 2	Slide the faceplate into place until it contacts all 4 Faceplate Spacers and the gasket is fully compressed against the inside of the barrel. Install the four (4) washers and hand tighten the four (4) mounting nuts. Additional turns might be required if the spacers are not flush with the foam pack, as per Step 1. After confirming the spacers are flush with the faceplate and the foam pack, use a 3/4" wrench to tighten the nuts an additional 1/4 turn. Be careful not to overtighten the nuts or cracking of the faceplate may result.
--------	---
