TECHNICAL SERVICE BULLETIN

Product: Cornelius Viper 60Hz

Subject: Condenser Fan PN replacement 620073140 – 2nd revision

Date: 6/29/2022

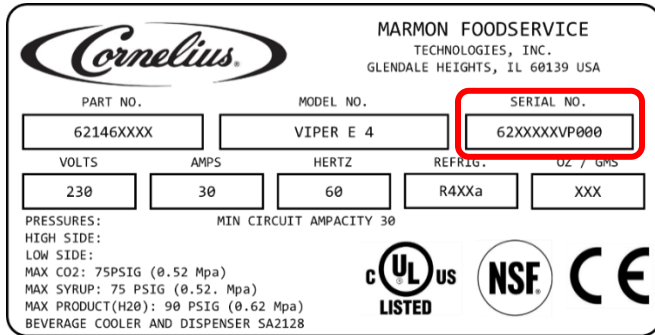
How to identify the Serial Number:

Serial Number contains the below segments.
Date Code **XXXX** is deciphered as **XX – year of manufacture**, **XX – week of manufacture**

Mfg. Version	Date Code	Viper	Unit Count
62D	XXXX	VP	001
62E			002
74D			003
74E			etc.
